Gem Trade LAB NOTES

AMBER, with Unusual Inclusions

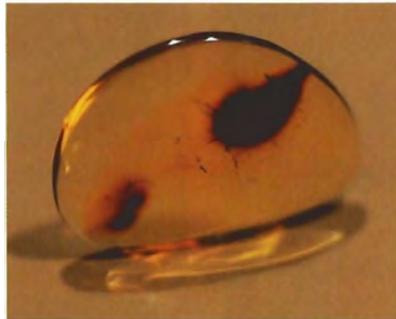
Figure 1. Metallic inclusion in Dominican amber.

Figure 1 illustrates a metallic inclusion in a fashioned piece of Dominican amber that the New York lab examined recently. The inclusion appears to be massive pyrite or marcasite, although the fact that iron and nickel are mined locally suggests that it may be bravoite $(Fe,Ni)S_2$, another member of the pyrite group. The reddish coloration around the inclusion indicates a chemical reaction with the amber. Such inclusions are encountered occasionally by amber workers and may present a problem in polishing. RC

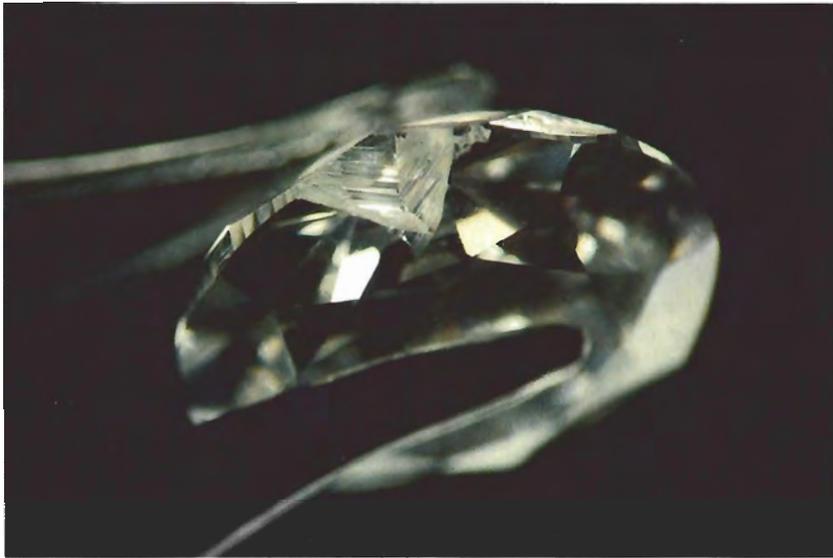
Figure 4. Blocked out 2.5-ct diamond that broke on the wheel. Magnified 10 \times .

When a diamond cutter has a blocked stone break on the wheel for no apparent reason (figure 4), he is usually philosophical and dismisses it as all in a day's work. However, when five out of a lot of 16 rough stones end up breaking, he begins to search for the reason. The possibility exists that rough material from certain mines has undergone serious deformation resulting in weak directions and internal strain. Unfortunately, the source of the approximately 2.5-ct diamond illustrated in figure 4 is not known. It is one of the five that broke on the wheel. RC

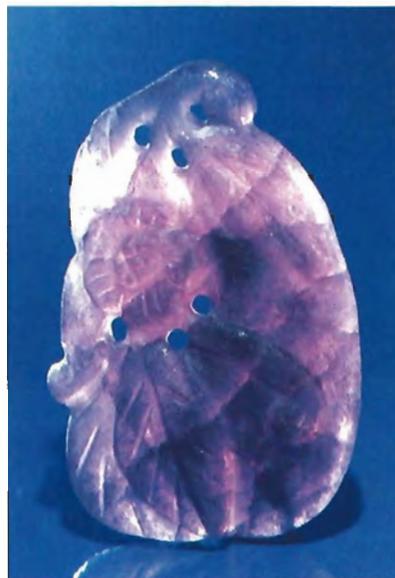
Figure 6. This fluorite carving, which measures approximately 45.75 \times 29.70 \times 11.90 mm, was originally thought by the owner to be amethyst.

The carving illustrated in figure 6 was sent to the Los Angeles labora-

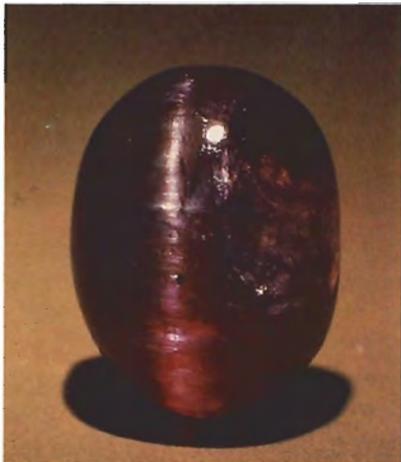
Figure 8. Cat's-eye hexagonite, 1.86 ct.

1.86 ct and 2.72 ct; figure 8 shows the smaller stone. These two rare cabochons were cut from material found at Fowler, St. Lawrence County, New York. Hexagonite also occurs at Edwards and Balmat, New York.

It has been reported in the past that many hexagonites are heavily fractured and therefore difficult to cut. Both of the cabochons that we examined were indeed heavily included, with parallel cleavage planes, fractures, parallel needles, opaque dark brown euhedral crystals, and irregularly shaped cavities filled with an opaque dark brown material. The properties of tremolite are compared with those of the cat's-eye hexagonites we examined in table 1. RK

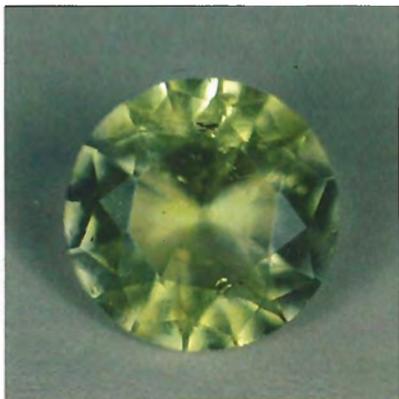
Figure 10. A 2.30-ct faceted yellowish green opal.

faceted, yellowish green opal (figure 10) that reportedly came from Mexico. Our first impression based on the oily appearance was that the stone might be highly fluorescent, particularly when it was examined in daylight at the window. Sure enough, the stone fluoresced an extremely strong, bright, yellowish green when exposed to either long- or short-wave ultraviolet radiation. The intense fluorescence seemed to follow the pattern of the internal botryoidal

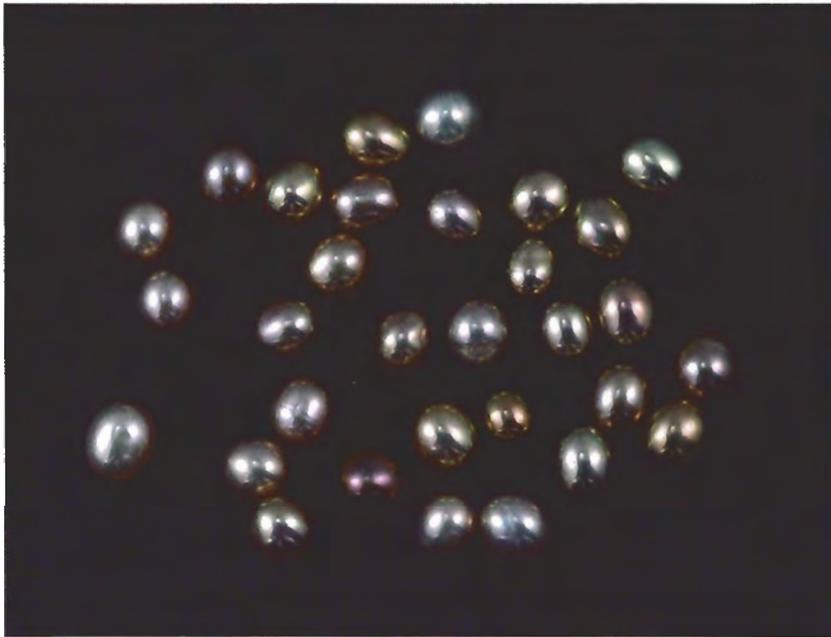
Figure 12. Some of the colors observed in the Chinese freshwater mantle tissue-nucleated cultured pearls examined in the Los Angeles lab (4–5.5 mm in diameter).

A large lot of undrilled fancy-colored pearls reported to be of natural origin were brought to our Los Angeles laboratory for identification. We were told that these pearls had been purchased in China. The pearls were all symmetrical in shape, primarily slightly off-rounds and ovals, and they ranged in size from approximately 4 to 5.5 mm in diameter. As shown in figure 12, the colors varied from different shadings of rose to purple, lavender, and bronze. They all showed a very high, almost metallic, luster. All of the pearls also showed a more or less strong fluorescence (depending on the intensity of their body color) when exposed to X-radiation, which indicates freshwater origin. The X-radiograph revealed the characteristic irregular voids that prove that these were mantle tissue-nucleated cultured pearls. These pearls had the most intense color and highest luster of any of the symmetrical freshwater cultured pearls that we have encountered to date in the Los Angeles laboratory. KH

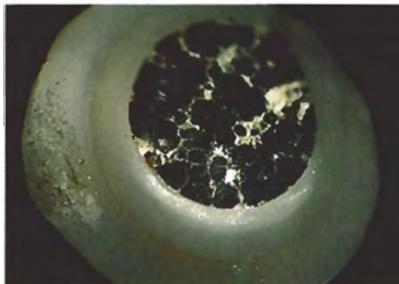
Figure 13. An 8-mm imitation pearl showing a metallic core and iridescent ring. Magnified 15×.

central core consisting of several small metallic spheres provided weight for the essentially plastic bead. Iridescence was provided by finely divided particles of unknown composition reminiscent of those seen in the Slocum imitation opal; these particles lay in a ring halfway between the metallic core and the surface (figure 13). The plastic above the iridescent layer is quite transparent and thick enough to allow repolishing if the bead were damaged. The usual coated imitation pearl

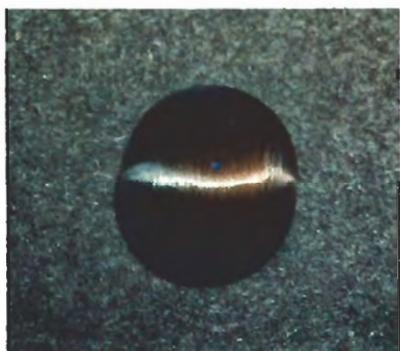
Figure 15. A 6.97-ct cat's-eye quartz.

The 6.97-ct cat's-eye quartz shown in figure 15 was submitted to the Los Angeles laboratory for identification. Refractive indices of 1.540–1.550 were obtained on the flat base of the cabochon. The specific gravity was determined to be approximately 2.67. No distinct bands or lines were observed in the absorption spectrum when the stone was examined with a hand-held spectroscope. The stone was inert to both long-wave (366 nm) and short-wave (254 nm) ultraviolet radiation. Examination with the microscope revealed numerous parallel long, thin, red needles throughout the stone, which caused the chatoyancy. Small, circular, orange disks were also observed throughout the stone. This is the first time that the Los Angeles lab has seen a cat's-eye quartz of this particular color. *RK*

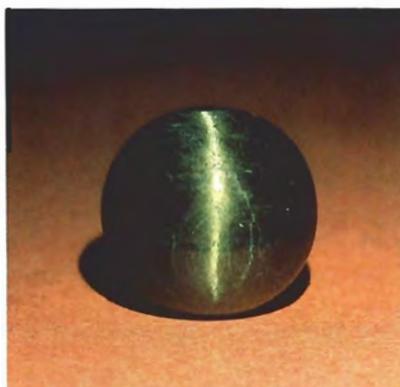
Figure 18. A dark green-brown cat's-eye scapolite, 52.92 ct.

The Los Angeles laboratory recently received for identification the 52.92-ct nearly opaque, extremely dark yellowish green-brown chatoyant round double cabochon shown in figure 18. Testing with a refractometer revealed a weakly birefringent spot reading at approximately 1.56. The cabochon was inert to long-wave ultraviolet radiation, but a barely perceptible red fluorescence was observed when the stone was exposed to short-wave ultraviolet radiation. The specific gravity was determined by the hydrostatic method to be approximately 2.70. Microscopic examination revealed minute, parallel needles throughout, as well as several large and small fractures. Using a

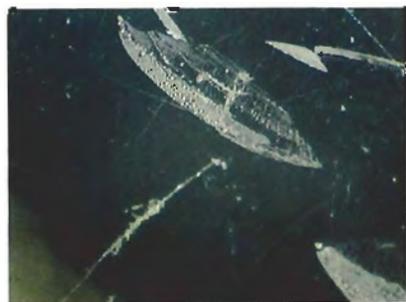
Figure 19. Gas bubbles appear in a "fingerprint" pattern in this glass imitation of topaz. Magnified 10x.

York lab for identification. The refractive index of 1.63 and the general appearance suggested a fine pink topaz. A cursory glance under low magnification disclosed what appeared to be "fingerprint" inclusions (figure 19). However, the stone proved to be singly refractive and the "fingerprints" to be nothing more than veils of gas bubbles—in glass. RC

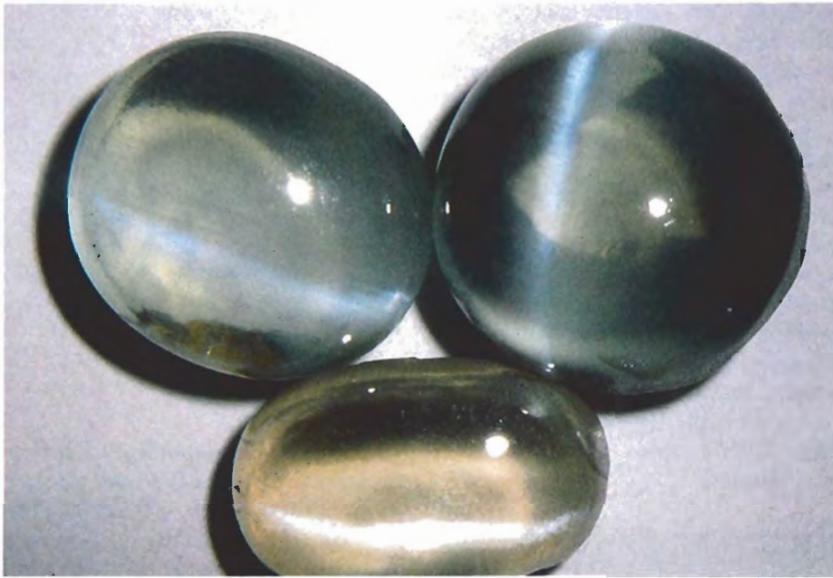
Figure 20. Three very translucent cat's-eye zircons that weigh 1.60, 2.28, and 2.97 ct, respectively.

The Los Angeles laboratory recently identified three cat's-eye zircons ranging from 1.60 to 2.97 ct (see figure 20). These chatoyant zircons were different in both color and diaphaneity from two cat's-eye zircons recently reported in *Gems & Gemology*: a 3.43-ct translucent, heavily included grayish green oval cabochon (Winter 1983), and an 8.63-ct translucent brownish yellow oval cabochon (Summer 1984).

The three stones we examined were all translucent and were light gray, light orangy brown, and medium gray, respectively, in color. They were reportedly from Sri Lanka. These three chatoyant cabochons were readily identifiable as zircon by the presence of characteristic absorption spectra. Numerous bands and lines were observed throughout the visible-light spectrum of each stone. Figure 21 shows a
