The Potential for diffusing Copper into Tourmaline Preparation for initial experimentation

Sudarat Saeseaw and Kenneth Scarratt
GIA Laboratory, Bangkok

(Updated July 27th, 2009)

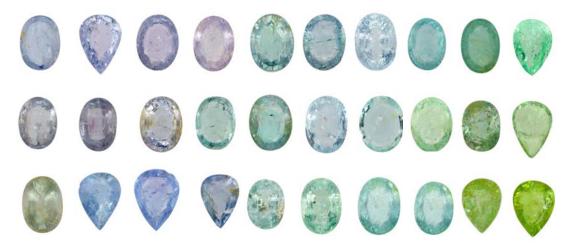
Figure 1: Thirty tourmalines selected for diffusion experiments seen here before treatment.

For this study a total of 30 faceted blue, green, blue-green, and violet samples have been examined; all are tourmaline and stated to be from Mozambique (Figure 1).

A New Wave UP-213 laser-ablation coupled with a Thermo X series II ICP-MS was used to obtain the full chemistry of all 30 samples (Figure 1). The laser-ablation parameters were; 40um spot diameter, ~10 J/cm2 laser fluence, 7 Hz repetition rate, and 25 second dwell time. NIST 610 and 612 glass reference material were used to calibrate and boron was used as internal standard. Boron was assumed as 3.26% for all tourmaline in this study. All tourmaline were elbite with 0.13-0.46 wt% CuO (1076.8 to 3636 ppmw of Cu) and 0.21-2.62 wt% MnO (1631.2 to 20260 ppmw of Mn) with the exception of two samples that did not contain Cu. In this study, most of violetish blue tourmalines have no Fe concentration while some (but not all) green tourmalines do have Fe content.

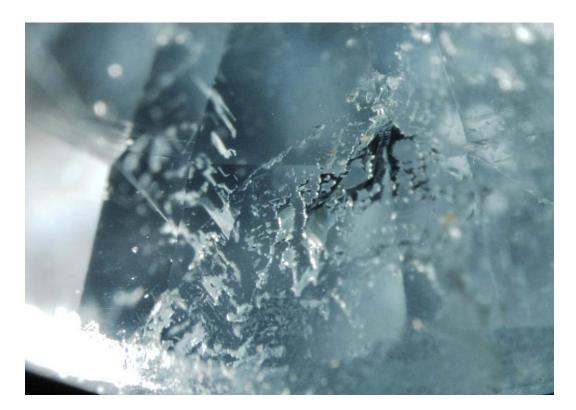
Figure 2: Partially healed fissures in one of the tourmaline selected for diffusion experiments.

All samples exhibited typical tourmaline inclusions. These included trichites (Laurs, 2008), irregular and partially healed fissures (Figure 2, Figure 3 and Figure 5) and parallel channels (Figure 4 and Figure 5). Some were cracked and some of these cracks were frosty in appearance.

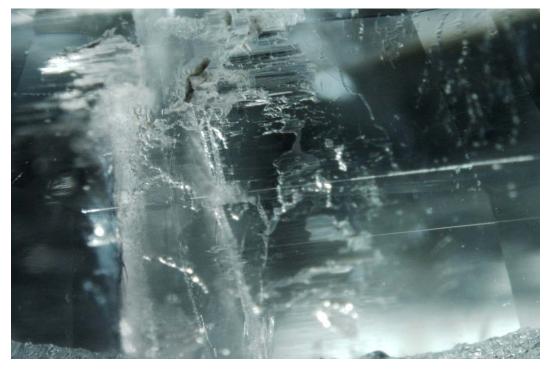
Figure 3: Partially healed fissures in one of the tourmaline selected for diffusion experiments.

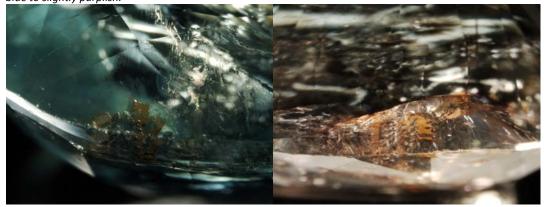
Figure 11: Sample 0668225902 comparable areas before (left) after heating at 700°C in air **for 10 hours** (right); no foreign elements were added before or during the heating process.

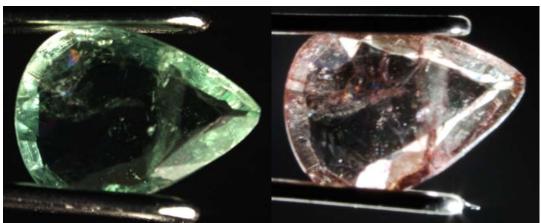
Figure 13: Sample 0668227002 before (left) after heating at 700°C in air **for 10 hours** (right); no foreign elements were added before or during the heating process. The overall face-up color impression changes from green to slightly purplish.

Stone 0668227002 (Figure 12) appeared green before heating and was quite purple afterwards (Figure 13); as before most of the perceived new color could be associated with material within fractures. However, some diffuse purple color gives the impression of coming from within the stone adjacent to, as well as being within, the fractures (Figure 16 and Figure 17).

Clearly the Kammerling and Koivula explanations of the color change process explain the fundamental changes in appearance of the tourmaline samples when heated under the conditions described here. However, the changes in color appearance are rather striking; see for example Figure 10, Figure 13 and Figure 30. Certainly, and contributing to the effect, it would appear that the limonite present in some fissures and within channels becomes mobile within the environment used at 700°C. This can be assumed by the change in color observed in fractures which did not (noticeably) contain limonite prior to heating, e.g., the fracture depicted in Figure 18 and Figure 19.

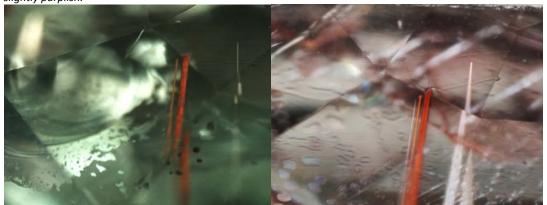
Figure 14: Sample 0668227002 comparable areas before (left) after heating at 700°C in air **for 10 hours** (right); no foreign elements were added before or during the heating process (see Figure 15 for a closer study).

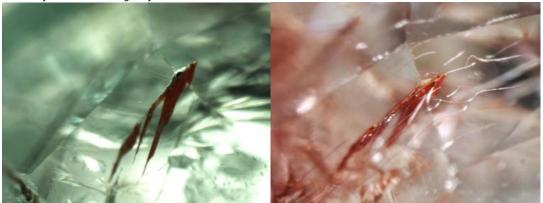
Figure 16: Sample 0668227002 comparable areas before (left) after heating at 700°C in air **for 10 hours** (right); no foreign elements were added before or during the heating process. (see Figure 17 for a closer study).

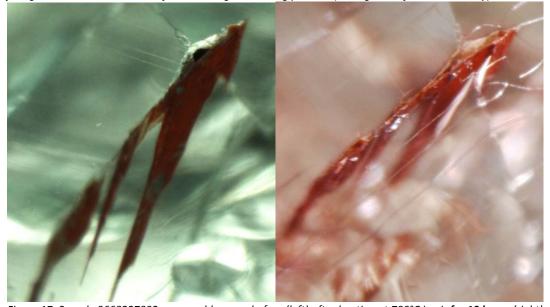
Figure 17: Sample 0668227002 comparable areas before (left) after heating at 700°C in air **for 10 hours** (right); no foreign elements were added before or during the heating process. The dark brown color of the material contained within the fracture in the left-hand image, has changed to brownish red in the right-hand image. This change has also impacted the background color. A close examination of the image on the right also indicates a possibility of the color 'bleeding 'into the body of the stone from the fracture.

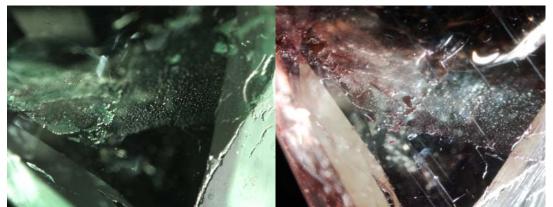
Figure 18: Sample 0668227002 comparable areas before (left) after heating at 700°C in air **for 10 hours** (right); no foreign elements were added before or during the heating process (see Figure 19 for a closer study).

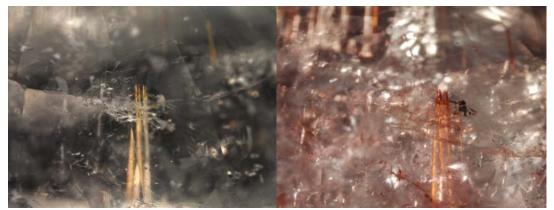
Figure 24: Sample 0668227202 comparable areas before (left) and after heating at 700°C in air **for 10 hours** (right) no foreign elements were added before or during the heating process (see Figure 25 for a closer study).

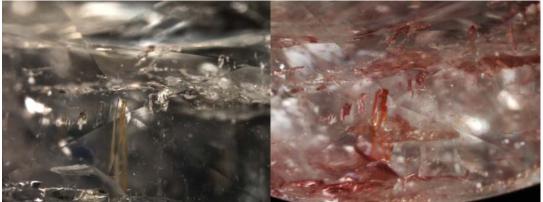
Figure 26: Sample 0668227202 comparable areas before (left) and after heating at 700°C in air **for 10 hours** (right) no foreign elements were added before or during the heating process (see Figure 27 for a closer study).

Stone 0668227202 (Figure 20) appeared to have a purplish tint before heating that seemed more intense afterwards (Figure 21). Again the increase in intensity appeared to arise in the main from the emergence of brown matter within fractures in addition to a change in color (from yellow to reddish brown) of material within some fractures and channels (Figure 25, Figure 26 and Figure 27).

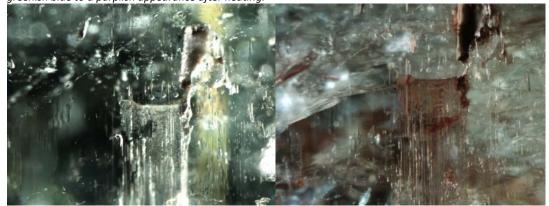
Figure 31: Sample 0668228402 comparable areas before (left) after heating at 700°C in air **for 10 hours** (right) no foreign elements were added before or during the heating process (see Figure 32 for a closer study).

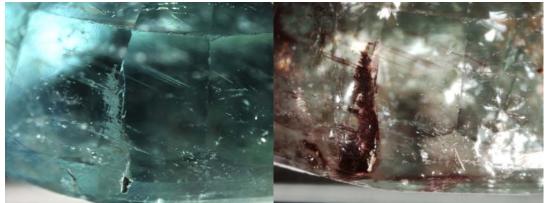
Figure 34: Sample 0668228402 comparable areas before (left) and after heating at 700°C in air **for 10 hours** (right); no foreign elements were added before or during the heating process. Here a fracture with a small amount of dark material present prior to heating has become a deep reddish brown throughout. Several channels have also become a reddish brown. These changes have also impacted the general color appearance of the area following the heat treatment.

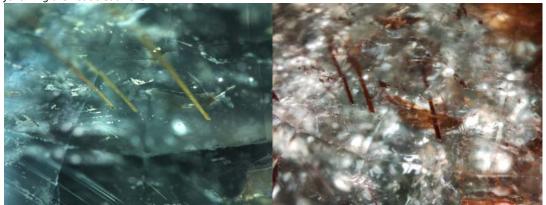
Figure 35: Sample 0668228402 comparable areas before (left) and after heating at 700°C in air **for 10 hours** (right); no foreign elements were added before or during the heating process. The color of these channels running top left to bottom right has changed from yellowish before heat treatment (left) to a deep reddish brown after (right). A fracture associated with the channel on the right also became reddish brown after heating.

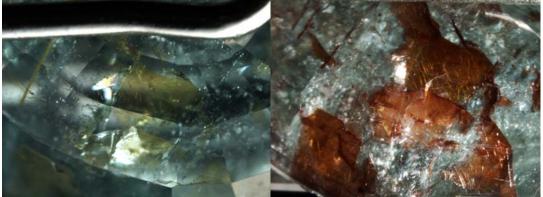
Figure 36: Sample 0668228402 comparable areas before (left) and after heating at 700°C in air **for 10 hours** (right); no foreign elements were added before or during the heating process. A fracture containing a light brownish material before heating (left) became a deep reddish brown after heating (right).

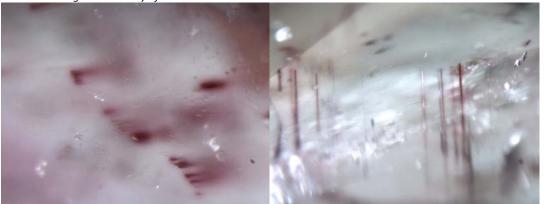
Figure 38: Channels in sample 0668227202 after heating at 700°C in air **for 10 hours**. In these images, similarly to that seen in Figure 37, there is a distinct impression that the color in these channels is bleeding into the body of the tourmaline.

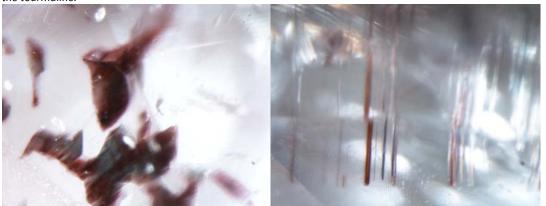
Figure 39: Channels in sample 0668227202 after heating at 700°C in air **for 10 hours**. In these images, similarly to that seen in Figure 37 and Figure 38, there is a distinct impression that the color in these channels is bleeding into the body of the tourmaline.

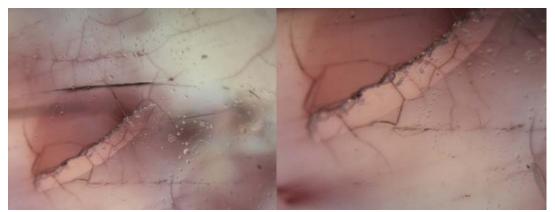
Figure 43: Fine fractures in sample 0668228402 after heating at 700°C in air **for 10 hours** (left) and at higher magnification (right). See also Figure 42.

Stone 0668228402 (Figure 29) appeared bluish green before heating while after its color appearance had changed to be more towards purple (Figure 30). The change in appearance appeared to arise again in the main from the emergence of reddish brown matter within fractures in addition to a change in color (from yellow to reddish brown) of material within some fractures and channels (Figure 31, Figure 32, Figure 33, Figure 34, Figure 35 and Figure 36). However, some diffuse reddish brown color again gives the impression of coming from within the stone adjacent to, as well as being within, the fractures (Figure 40, Figure 41, Figure 42 and Figure 43).

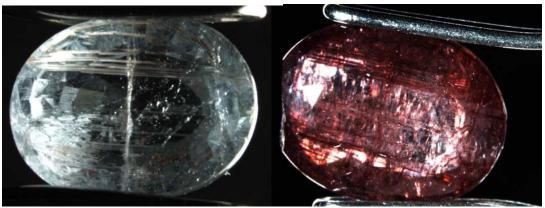
Figure 45: 0668227502 before heating (left) and after heating at 700°C in air **for 100 hours**; no foreign elements were added before or during the heating process. Here the face-up color appearance has considerably altered from greenish blue to an intense reddish purple. Note that the left portions of this stone broke off during the heating process, see Figure 52 for detail.

After heating for 100 hours the face-up color appearance of stone 668227502 (Figure 44) considerably altered from greenish blue to intense reddish purple (Figure 45). Figure 45 to Figure 52 detail the stone and the changes that were noted

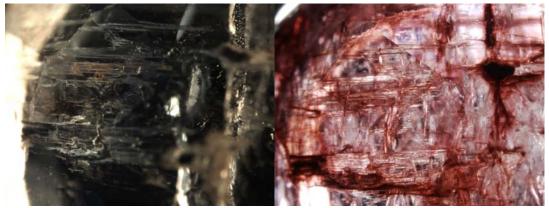
Figure 48: 0668227502 comparable areas before heating (left) and after heating at 700°C in air **for 100 hours**; no foreign elements were added before or during the heating process. This figure details the lower portion of Figure 47 and the before and after appearance of fractures within that area. Again, there appears to be some color bleeding into the tourmaline from the fractures.

following heating; Figure 46, Figure 47, and Figure 48 show a clear change in the color from yellow to reddish brown of material lining channels and some fractures and clearer indications of color bleeding into the tourmaline than were noted in stones heated for only 10 hours. Figure 49 to Figure 51 again detail a significant change in color appearance of both channels and fractures (the right hand images of Figure 51 also showing indications of color bleeding into the host tourmaline) while Figure 52 shows the cross-section of the broken end of the stone (broken during the heating process, see Figure 45) at two magnifications detailing the extent to which the material lining channels and fractures becomes mobile during the heating process and both changes color and lines all available fractures.

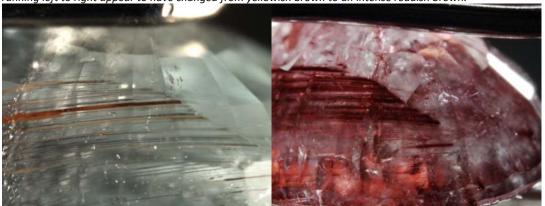
Figure 50: 0668227502 comparable areas before heating (left) and after heating at 700°C in air **for 100 hours**; no foreign elements were added before or during the heating process. The color of the material within the channels running left to right appear to have changed from yellowish brown to an intense reddish brown.

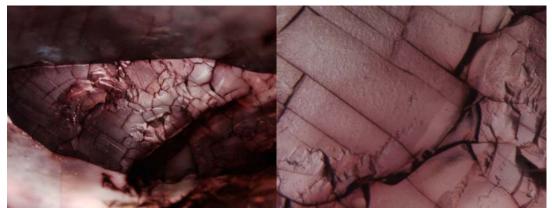
Figure 51: 0668227502 comparable areas before heating (left) and after heating at 700°C in air **for 100 hours**; no foreign elements were added before or during the heating process. The color of the material within the channels running left to right appear to have changed from yellowish brown to an intense reddish brown and fractures surrounding these have gained the same color.

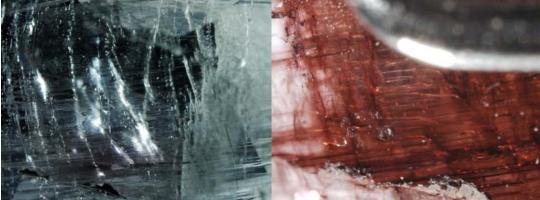
Figure 56: 0668227702 comparable areas before heating (left) and after heating at 700°C in air **for 100 hours**; no foreign elements were added before or during the heating process. A view of the fracture seen in Figure 55 from a different (lower) angle, a dark material is apparent where the fracture meets the surface of the stone but is not seen deep within prior to heating (left) after heating the fracture appears a distinct reddish brown.

For stone 0668227702 before heating at 700°C the color of the sample was blue, after heating it changed to a reddish brown / blue mixture (Figure 54). Figure 55, Figure 56 and Figure 57 depict a single large fracture at differing angles and magnifications both before and after heating. The change in color appearance of the fracture is rather striking. The lower portion of the right hand image in Figure 56 also shows several smaller fractures that are colored reddish brown following treatment. These smaller fractures are further depicted in Figure 61 and Figure 62 where possible bleeding of color into the host tourmaline maybe seen.

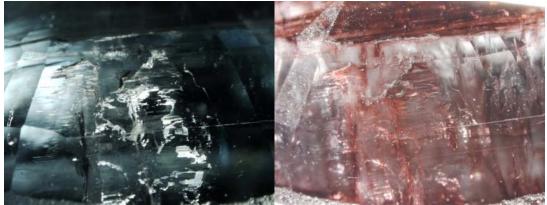
Figure 57: 0668227702 comparable areas before heating (left) and after heating at 700°C in air **for 100 hours**; no foreign elements were added before or during the heating process. A closer view of the fracture seen in Figure 55 and Figure 56 showing the dark material that is apparent where the fracture meets the surface of the stone but is not seen deep within prior to heating (left) after heating the fracture appears a distinct reddish brown while the material present where the fracture meets the surface now appears light in color.

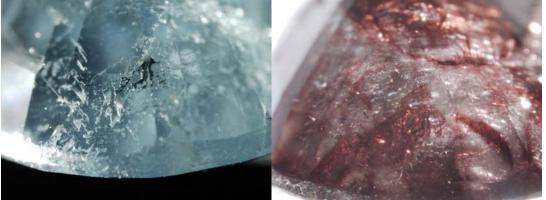
Figure 58: 0668227702 comparable areas before heating (left) and after heating at 700°C in air **for 100 hours**; no foreign elements were added before or during the heating process. The partially visible fracture in the center of

the image on the left appears reddish brown in the image on the right.

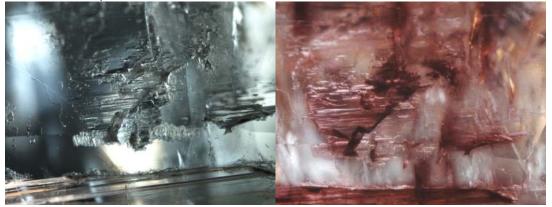
Figure 59: 0668227702 comparable areas before heating (left) and after heating at 700°C in air **for 100 hours**; no foreign elements were added before or during the heating process. The partially visible fracture in the left-center of the image on the left appears reddish brown in the image on the right as do several other fractures following the heat treatment process.

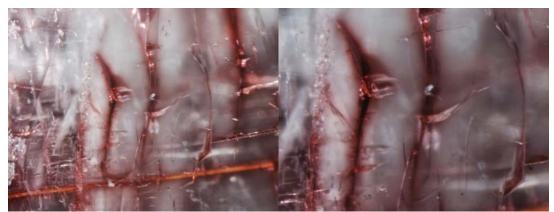
Figure 60: 0668227702 comparable areas before heating (left) and after heating at 700°C in air **for 100 hours**; no foreign elements were added before or during the heating process. The partially visible fracture in the center of the image on the left and the fracture running west-east at the bottom of the image appear reddish brown in the image on the right as do several other fractures following the heat treatment process.

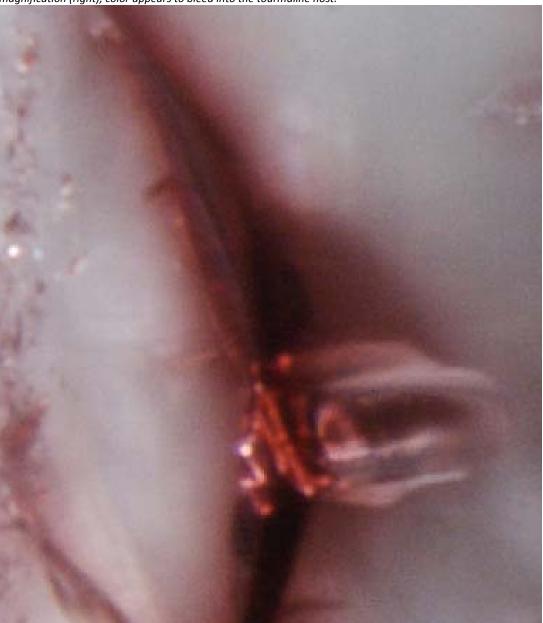
Figure 61: 0668227702 after heating at 700°C in air **for 100 hours**; no foreign elements were added before or during the heating process. Deep reddish brown coloration in fractures running north-south (left) with a higher magnification (right), color appears to bleed into the tourmaline host.

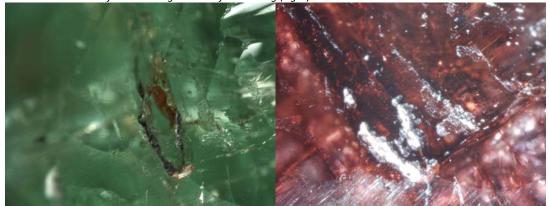
Figure 66: 0668228002 comparable areas before heating (left) and after heating at 700°C in air **for 100 hours**; no foreign elements were added before or during the heating process. A dark material can be seen at the entrance to the channels in the left-hand image which after heating (right) have become an intense reddish brown.

The color of sample 0668228002 before heating at 700°C was green, after treatment this changed to an intense purplish red (Figure 64). The change in the appearance of this stone is possibly one of the most striking. Figure 65, Figure 66 and Figure 67 reveal the intensity of the changes to specific areas of the stone. While Figure 68 shows how the reddish brown post heating color appears in multiple smaller fractures.

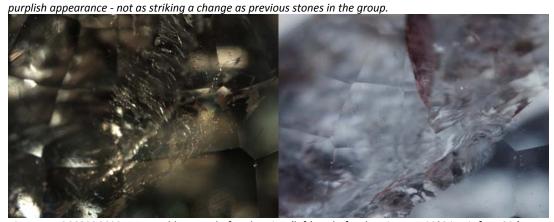
Figure 70: 0668226602 before heating (left) and after heating at 700°C in air **for 100 hours**; no foreign elements were added before or during the heating process. Greenish blue before treatment, this stone now has a slight

Stone 0668226602 before heating was greenish blue while after it had gained a slight purplish appearance - not as striking a change as previous stones in the group (Figure 70). However, one group of fine fractures (Figure 73 and Figure 74) shows how in this instance the material (and therefore the color) is lining the surfaces of the fracture with the color apparently showing some slight bleeding into the stone.

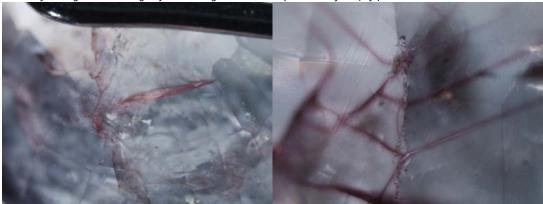
Figure 72: 0668226602 comparable areas before heating (left) and after heating at 700°C in air **for 100 hours**; no foreign elements were added before or during the heating process. A purplish color has appeared in the fracture center of the right-hand image after heating that was not present before (left).

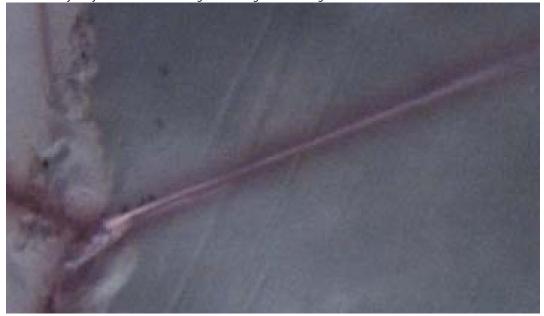
Figure 73: 0668226602 after heating at 700°C in air **for 100 hours**; no foreign elements were added before or during the heating process. A purple color is seen to have appeared within several fractures. See Figure 74 for a closer view of the fracture seen lower right in the right hand image.

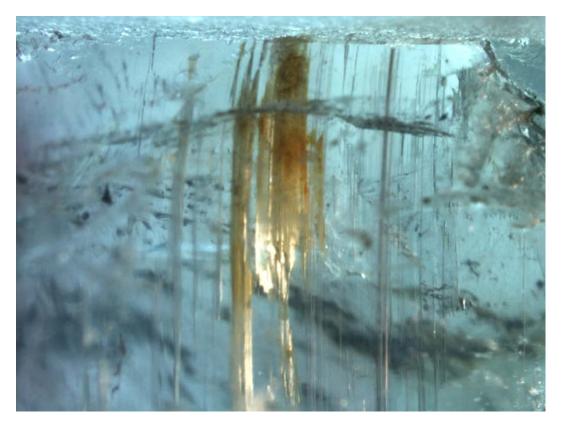
Figure 76: Partially healed fissures and growth tubes in the tourmaline examined for this study

Raman spectroscopy was used (prior to any fabrication) to confirm that this stone was tourmaline. The inclusions present are the classic (tourmaline) trichites, partially healed fissures and growth tubes of which some are filled with a yellow material. Pinkish purple color zones are clearly evident and appear associated with some fractures and growth tubes. (See Figure 76 to Figure 79)

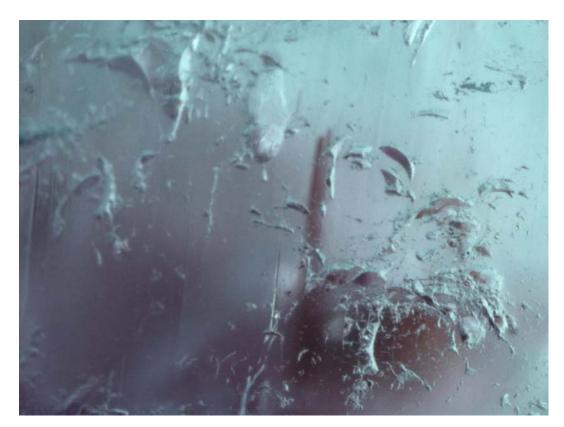
Figure 78: Unusual pinkish purple coloration in growth tubes and cracks in the sample stone.

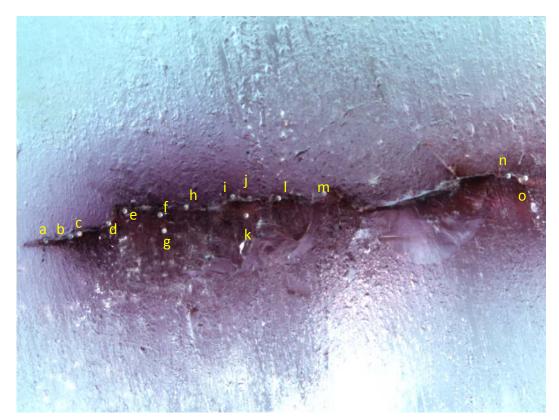
Figure 82: Enlarged photomicrograph of the ²³⁸U mapping from Figure 80.

Further, using LA- ICP-MS to map the chemistry of the rough surface a series of 24 samplings were taken of the stone from the green area right up to a fracture that contained a pinkish purple coloration (Figure 80). Neither thorium (²³²Th) nor uranium (²³⁸U) were detected in the green area however, both were detected in some pinkish purple colored areas (Figure 81 and Figure 82).
